# **PCBs** in the Bluestone River

## PCB TMDL SOURCE ASSESSMENT STUDY, BLUESTONE RIVER WATERSHED

Craig Lott and Allen Newman, Virginia Department of Environmental Quality

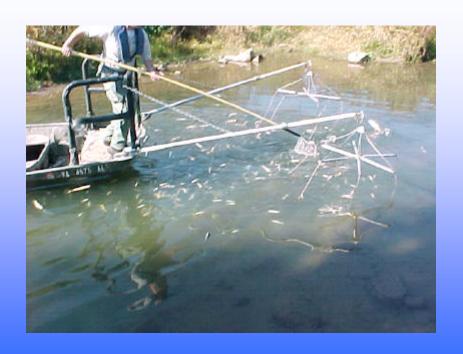
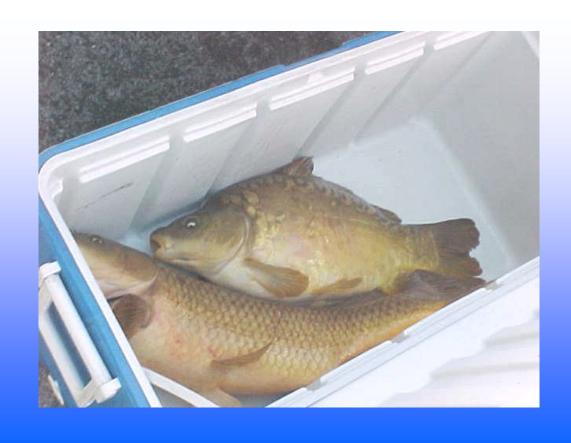
FIGURES 6 & 7. Bluestone Virginia Water Treatment Plant Fish Sampling with VDGIF.

Coordination was done with VaDGIF (Virginia Department of Game and Inland Fisheries), the DEQ Sampling and Monitoring group, and local residents, to sample fish at the intake reservoir and take sediments from strategic locations above the water supply (see Figures 6 & 7). This follow up sampling event occurred October 2003. The fish tissue data revealed that carp had 300 ppb of PCBs. The sediment results indicate fairly low concentrations in various locations above the drinking water source, ranging from 0.32 ng/g at the BVWTP to 8.97 ng/g upstream on the mainstem. Even if fish in the reservoir were exposed to a concentration in the sub ppb (ng/g) range, evidence supports that these low levels are enough to reach PCB concentration levels in the fish above the edible fish tissue consumption advisory level of 50 ppb.

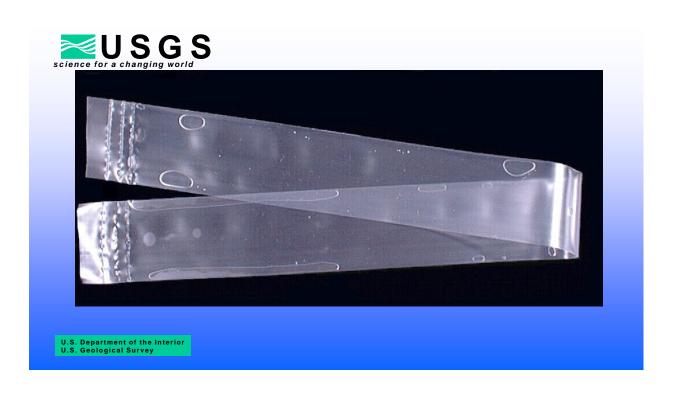
FIGURE 12. Photograph, SemiPermeable Membrane Device Triolein Fish Oil in Polyethylene 'Lay Flat' bags.

7) Semi-Permeable Membrane Device Study: DEQ wished to determine the PCB loading by the various tributaries in the watershed in order to determine the total maximum daily loads (TMDLs) for the watershed. Semi-Permeable Membrane Device (SPMDs) were selected as the appropriate sampling device. The study design includes deployment of SPMDs at two times during the year, at seasonal high and low streamflows. The SPMDs are called 'virtual fish' for their ability to uptake chemicals such as PCBs and accumulate them with measurable kinetics that can be used to calculate the levels of contamination in a water body. The SPMDs uptake only the dissolved fraction which is the readily bioavailable form.

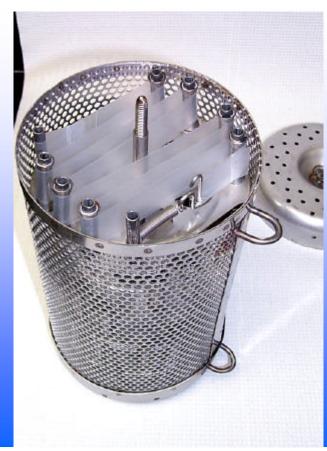
# FIGURE 15. Photograph, SPMD Example of a Protective Shroud.

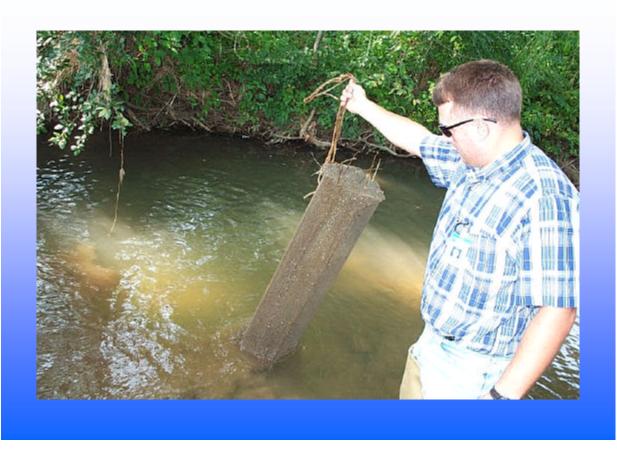
### FIGURE 18. SPMD Deployment in Bluestone River Watershed.

Sample deployment locations were selected to represent various areas within the watershed. The first location selected was the public water supply for the Town of Bluefield, VA to help answer the health risk exposure concerns. Survey responses indicated several potential sources above the drinking water intake, if the WTP had been contaminated. The second site, Camp Joy, was selected upstream of the filtration plant uptake for two reasons: 1) A more upstream sample above the WTP would either provide a clean reference site and eliminate some potential sources above the device, or 2) help pinpoint the contamination source. The third site was located in Wright's Valley Creek, just above the confluence with the Bluestone. A foundry located on the banks of Wright's Valley Creek was reported to historically take metal parts for melting that might have contained or been coated with PCB oils. Another facility nearby, repaired mining machinery and appeared to have large quantities of oil in the ground at multiple locations. The fourth sampling site was in Beaverpond Creek, just above the confluence with the Bluestone River. The Beaverpond Creek location was critical for various reasons. Three known EPA Superfund cleanup sites, two PCB and one dioxin, were located on the drainage; as well as stakeholders reports of additional suspicious PCB activity sites. The fifth site was the sewage treatment plant. Sludge from the BVWTP was flushed down to the STP. This could dramatically increase the amount of PCBs this site could have if the BVWTP were effectively

removing PCB laden particulates from river water. Additionally, there were reports of various industrial practices, such as pouring barrels of PCB contaminated oils down the storm and sewer drains. Some sewer pipes might continue to release PCBs dumped years ago from their contaminated linings. The sixth sampling site was selected upstream of Brush Fork confluence with the Bluestone River. Brush Fork is just above a second Virginia Sewage Treatment Plant, STP, and this STP by this tributary and Mud Fork. Contamination from various transformer maintenance shops which operated historically up this valley in West Virginia would be trapped in the SPMD located in Brush Fork. Mud Fork, the seventh sampling site, provided a drinking water source to much of Bluewell, WV, however it doesn't have industrial development or much reported reputation for contamination. The eighth sample location was along the mainstem of the Bluestone River just before the river crossed into West Virginia at Yards.
